**HYDROGEOLOGIC ANALYSIS OF THE
PROPOSED EXPANSION OF THE
HANSON AGGREGATES NEW YORK LLC
HONEOYE FALLS QUARRY**

**Alpha Geoscience
679 Plank Road
Clifton Park, New York 12065**

April 1, 2013

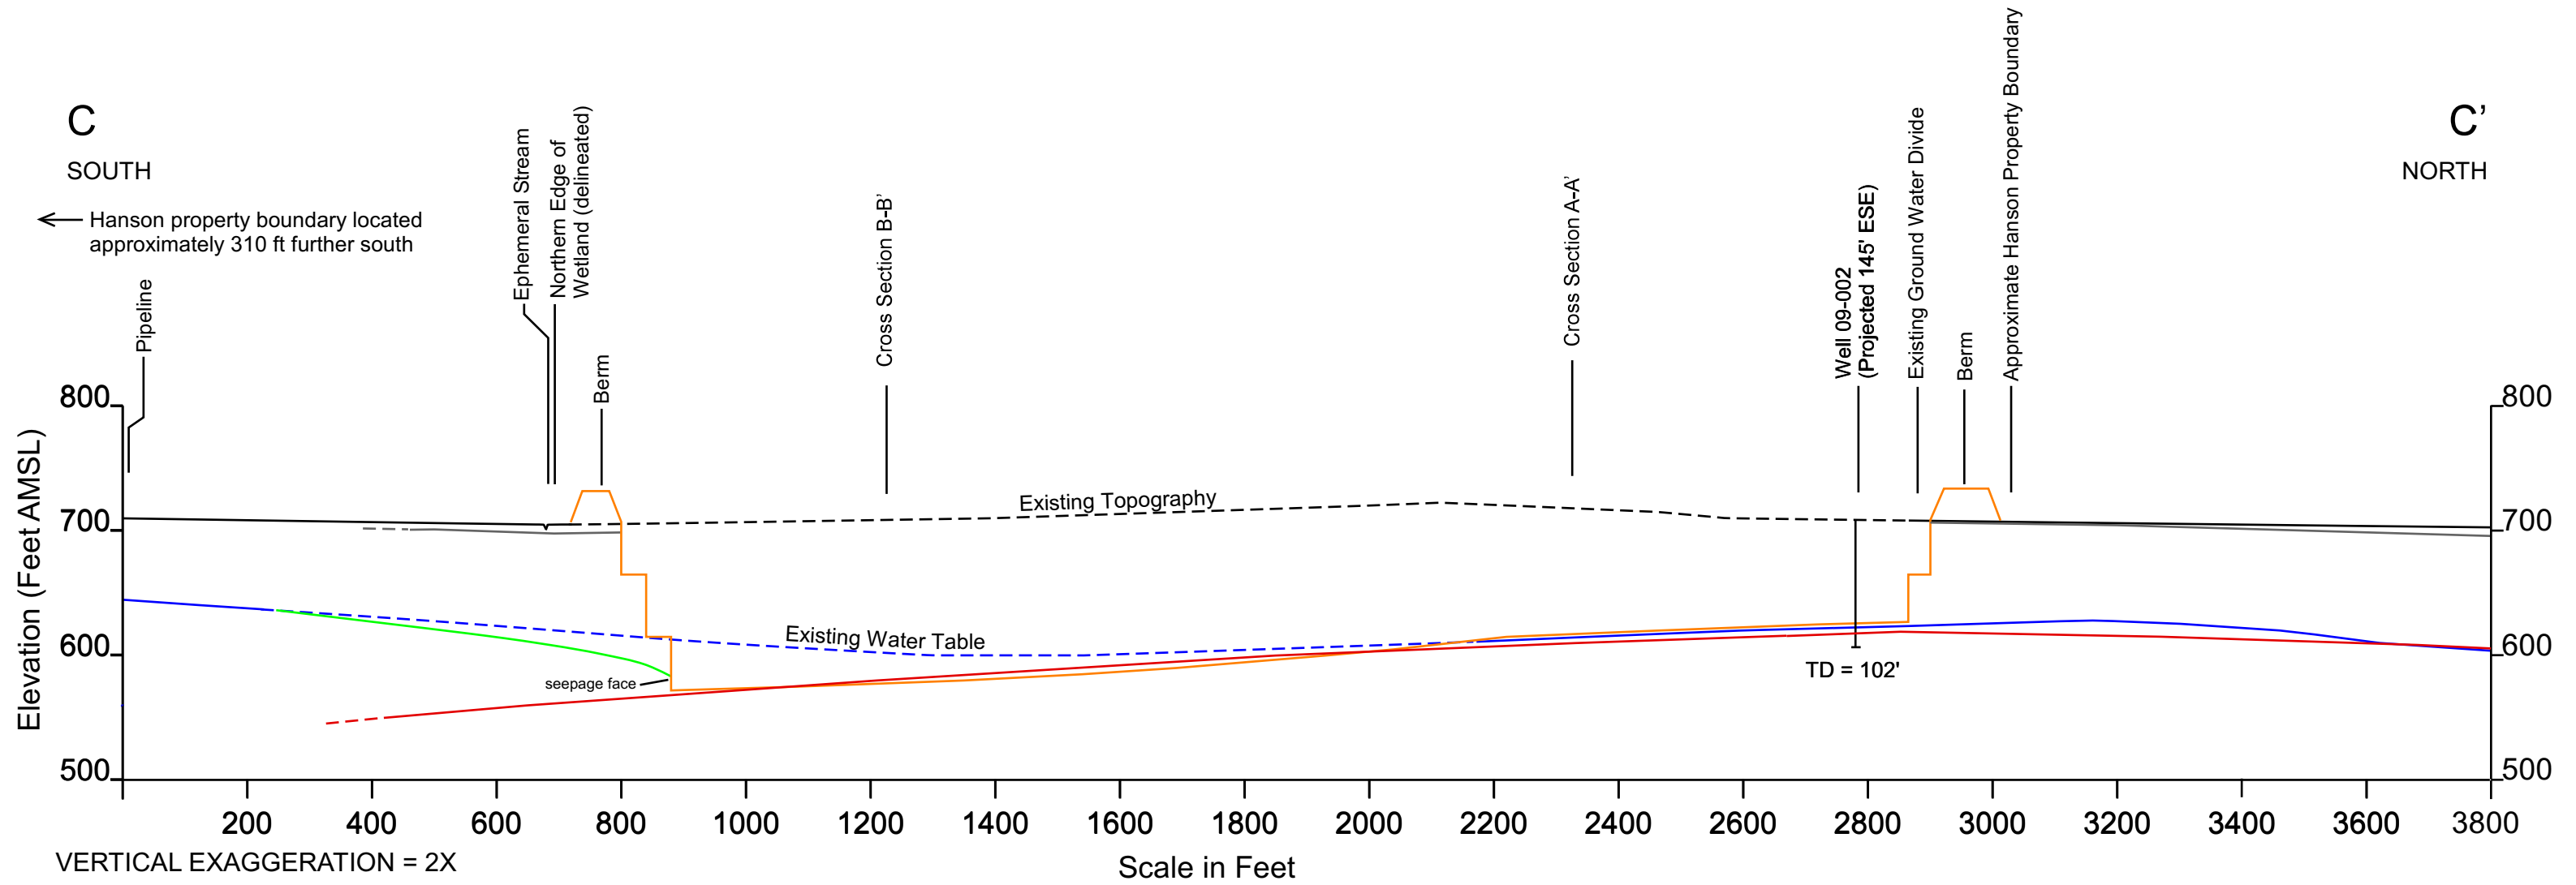
Figure 10
 Hydrogeologic Cross-Section C-C'
 Full Mine Expansion

- Proposed Quarry Expansion
- Top of Bedrock Surface
- Top of Bertie Group (Akron Fm)
- Water Table
- Future Water Table at End of Mining

Well location shown is extrapolated to the cross-section line (refer to Figure 7)
 Water Table and Top of Akron surfaces shown are based on the contours in Figures 7 and 4, respectively.
 Quarry profile based on contours in Figure 12.

Hydrogeologic cross sections A-A', B-B' and C-C' were constructed and are included as Figures 9, 10 and 11. The existing topography, top of rock surface and top of Bertie (Akron) surface are depicted on the cross sections. The seasonal low water table, represented by the August 23, 2010 ground water contours (Figure 7), is shown on each of the cross sections. Hanson's mine reclamation plan for the Honeoye Falls quarry, including the existing quarry and the expansion area, is included as Figure 11. Figure 11 shows the proposed quarry floor topography and the locations of the quarry faces and benches. The proposed quarry floor elevations were transferred to the hydrogeologic cross sections. The cross sections depict how the mine plan is to excavate the Onondaga Fm limestone down to, or almost down to, the Akron Fm. The mine plan was constructed by Hanson personnel and the top of the Bertie Group (Akron) elevation was interpreted by Alpha; consequently, there are subtle differences in the proposed quarry floor and the top of the Akron Fm surface as shown on the cross sections. It is Alpha's understanding that Hanson has no intention to mine below the Onondaga Fm.

Cross section B-B' and C-C' indicate that seepage faces are predicted for the southern portion of the proposed western quarry wall and on the proposed southern wall during seasonal low water table conditions. The seepage faces are anticipated to be approximately one-third the vertical distance between the mine floor (base of Onondaga Fm aquifer) and the elevation of the existing seasonal low water table. The impacts from water table (bedrock aquifer) drawdown west of the southern portion of the proposed mine expansion area are projected to extend approximately 625 ft westward from the quarry face when the water table is at its seasonal low (Figure 9). The projected impacts in that area are all within the Hanson property boundary and there are no residential wells within that area. The drawdown impacts south of the proposed southern quarry face are anticipated to extend approximately 500 ft south of the mine (Figure 10). The projected drawdown impacts south of the proposed expansion area also are still within the Hanson property only, and no residential wells are present in that area. The ground water divide that currently exists within the proposed expansion area during low water conditions will remain relatively unchanged because the water table will be at, or below, the quarry floor. The location of the divide will shift westward in the area west of the southern half of the proposed expansion area by less than 100 ft (Figure 9).
